Manhole Inspection Summary

Manhole # S35Y1_009MH

Location Address: **3916 Hanover St.**

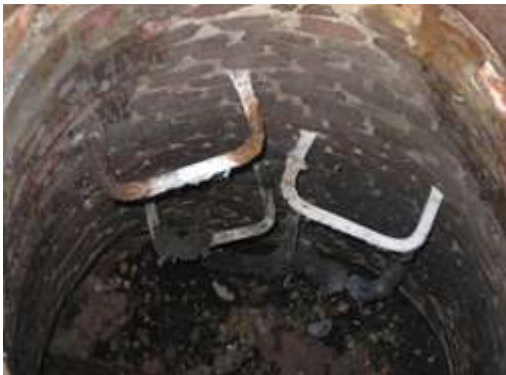
Steps Count: **5** Missing: **0** ☐ Corroded

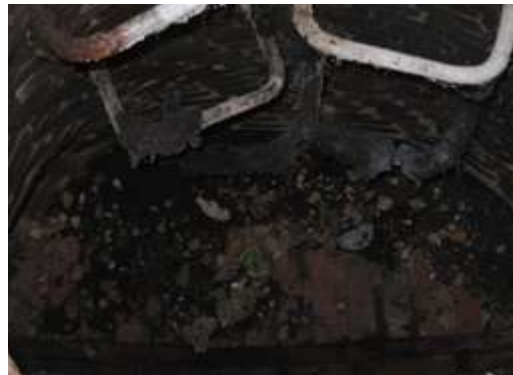
Defect 2

Condition: ☐ Sound ☐ Cracked ☐ Root Intrusion ☐ Deteriorated ☐ Leaks ☒ **Debris**

Debris on bench

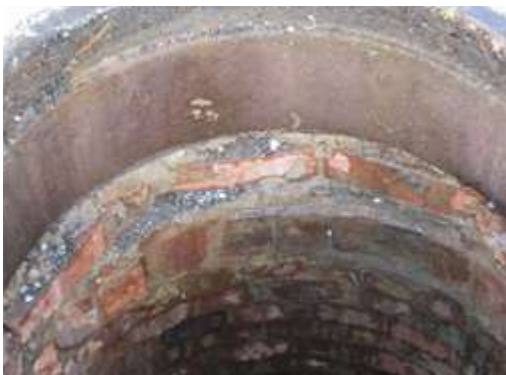
Defect 1

Frame Offset: **1** (in.) Condition: ☒ Sound ☐ Cracked ☐ Leaks

Frame offset/intrusion

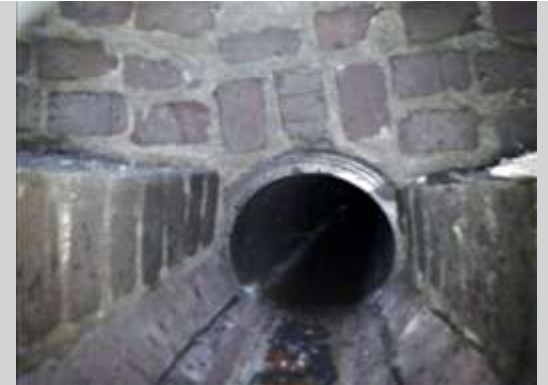
12 O'Clock Outflow

10 in. Circular Gravity Sewer
Pipe Out @ 12 O'Clock

Pipe Height: **9.6** (in.) Rod and Bar (Angled)
Pipe Material: **Clay** ☐ Pipe Lined
Invert Depth: **10.51** (ft.) Flow Characteristics: **Fast**
Deposits: ☒ None ☐ Mud ☐ Sludge ☐ Debris ☐ Grease
Silt Depth: (in.) Deposits Extent:
Infiltration: **None** Pipe Seal Cond: **Sound**

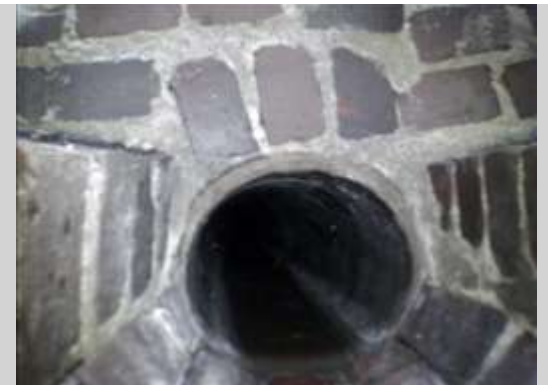
6 O'Clock Inflow

10 in. Circular Gravity Sewer
Pipe In @ 6 O'Clock

Pipe Height: **9.6** (in.) Rod and Bar (Angled)
Pipe Material: **Clay** ☐ Pipe Lined
Invert Depth: **10.58** (ft.) Flow Characteristics: **Fast**
Deposits: ☒ None ☐ Mud ☐ Sludge ☐ Debris ☐ Grease
Silt Depth: (in.) Deposits Extent:
Infiltration: **None** Pipe Seal Cond: **Sound**
